August 8, 2014 – Report to File –  
Twin Falls WWTP Manhole Collection Box Failure  
By Dr. Balthasar B. Buhidar, Regional Water Quality Manager

On August 7, 2014 the DEQ (Sonny Buhidar & Sue Switzer) visited the Twin Falls WWTP and spoke with Jack Bennion about the flood failure of the cement Manhole Collection Box that is near the UV Housing. The facility is also under upgrade construction. We visited the Manhole Collection Box that had failed (effluent perforated through the grout seal) and effluent discharged near the UV Housing and elsewhere on the site where the lowest elevation were located. The following two digitals show the Manhole Collection Box (red arrow).

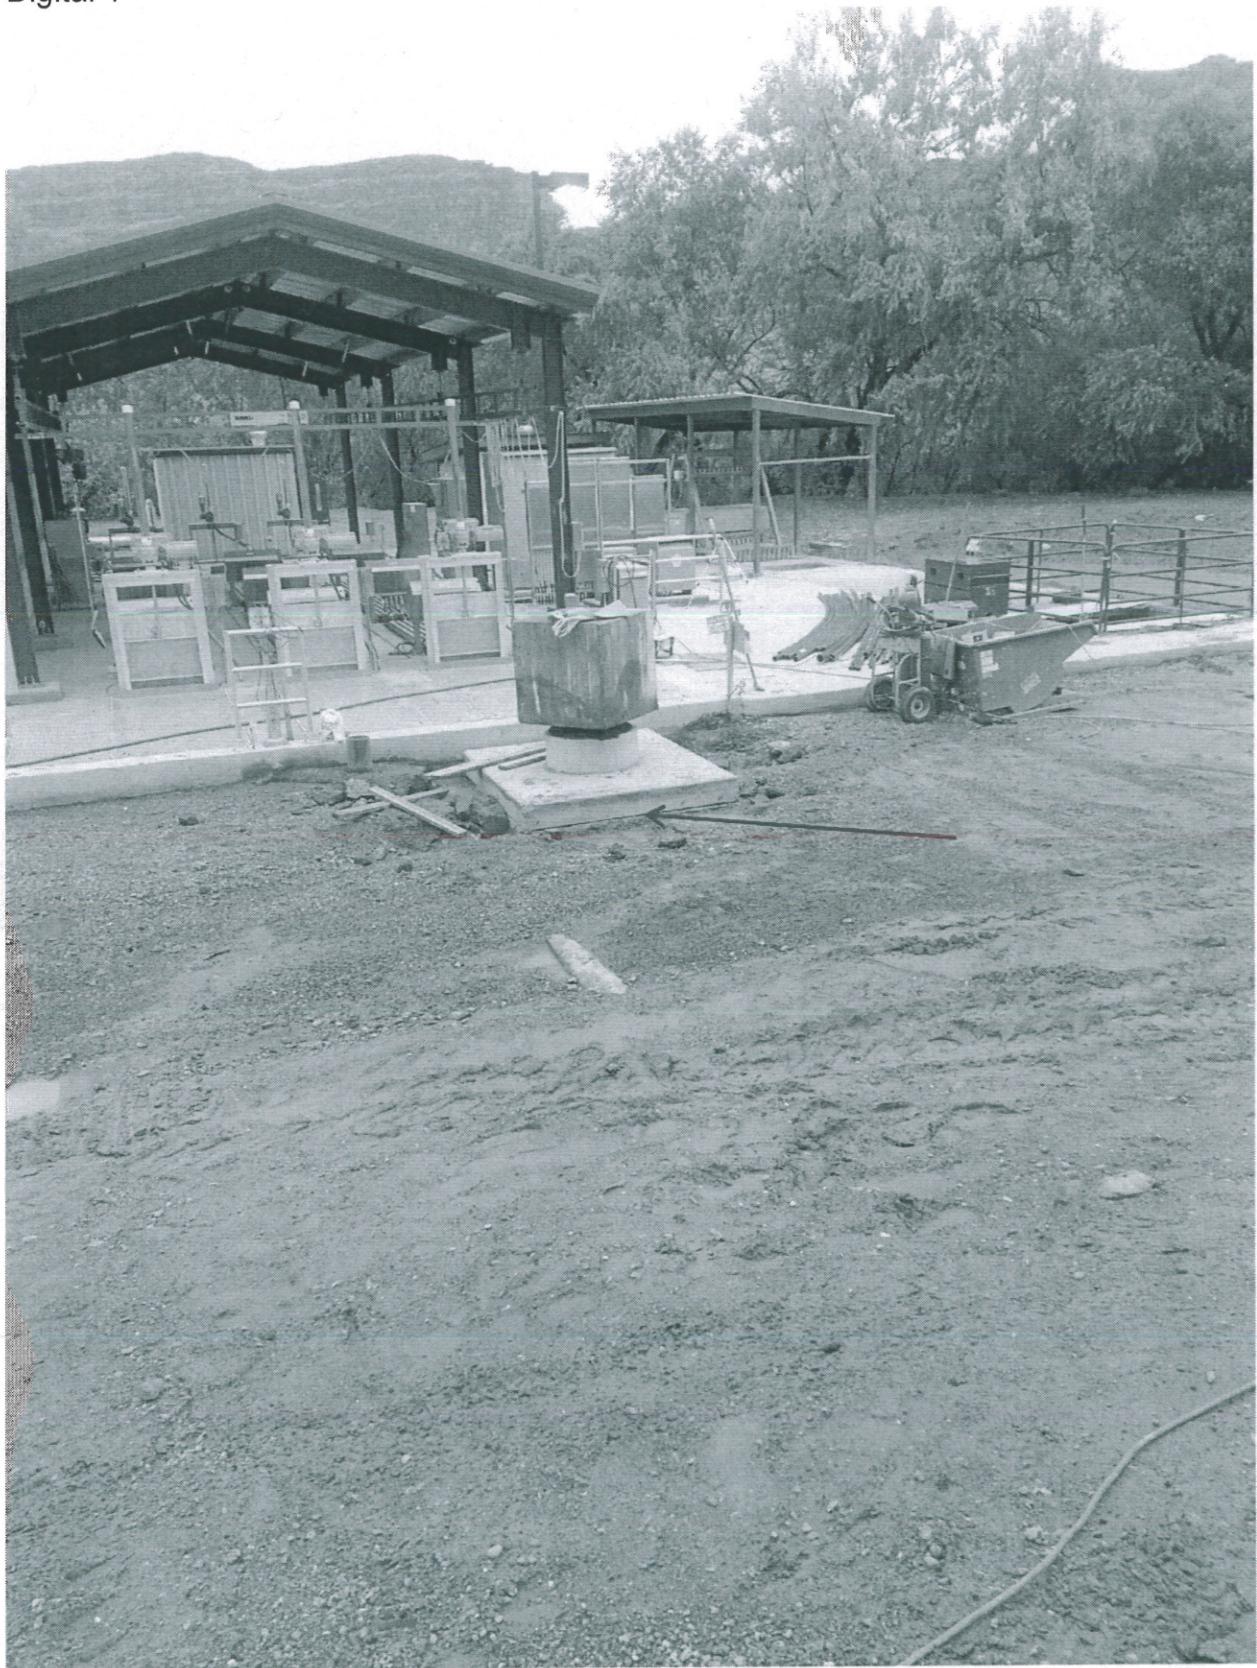
Digital 1

Digital 1. UV Housing in the background. The cement Manhole Collection Box is shown by the red arrow. Note the large concrete block that has been placed to maintain the structure in place. Grout-fill will be added as the facility ground starts to dry out. The Snake River is behind the line of trees and riparian vegetation behind the UV Housing.

The capacity of the Twin Falls WWTP is approximately 10 mgd for flow. What was going through the plant on August 5-6, 2014 was averaging around 16 mgd, with spikes as high as 20 mgd. That amount of pressure built up in the Manhole Collection Box forced the grout seal to crack; to which the effluent spilled through the crack and continued to run until the rain subsided and flows into the plant eventually reduced in volume a day later.

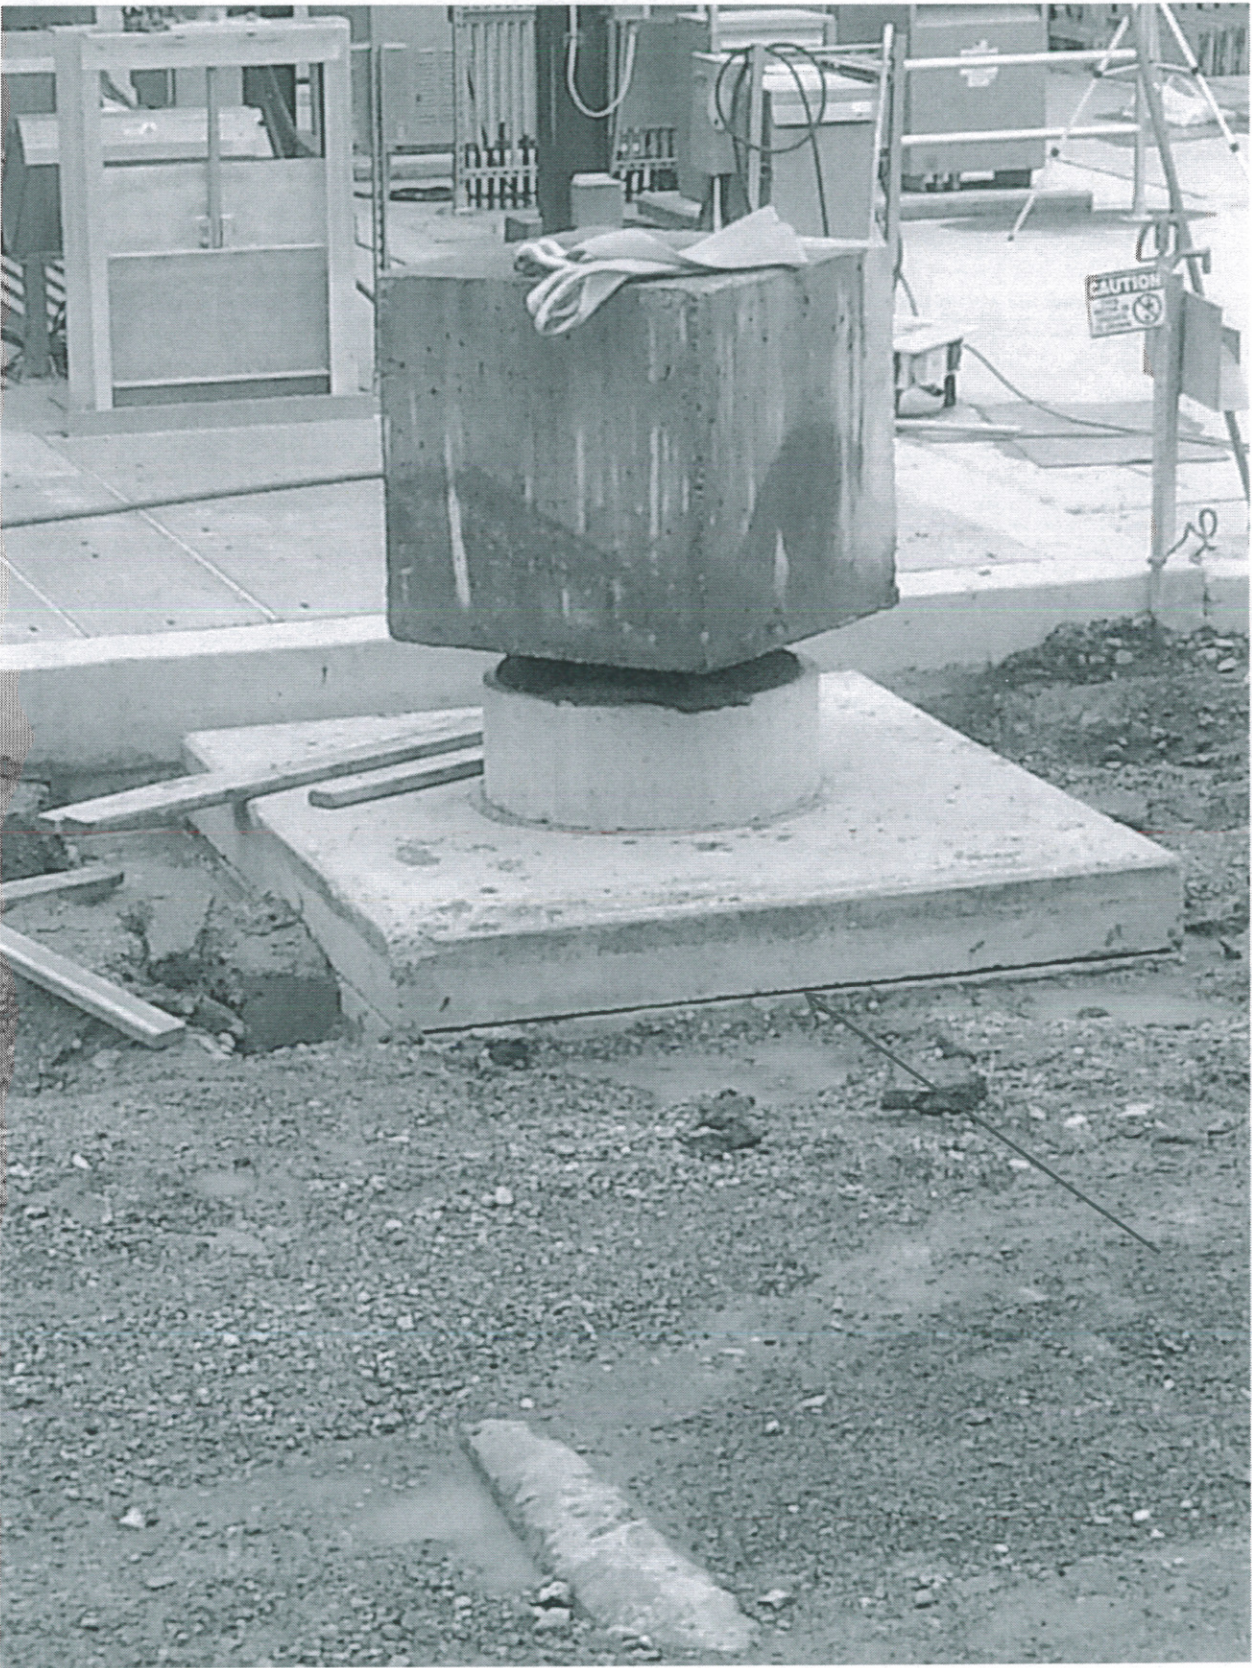
Digital 2. Closer view of the cement Manhole Collection Box held in place by the large cement block. The red arrow shows what the water pressure did to the grout-fill and forced the grout seal to break. The manhole itself held, but the effluent poured out through the grout seal of the cement Manhole Collection Box.

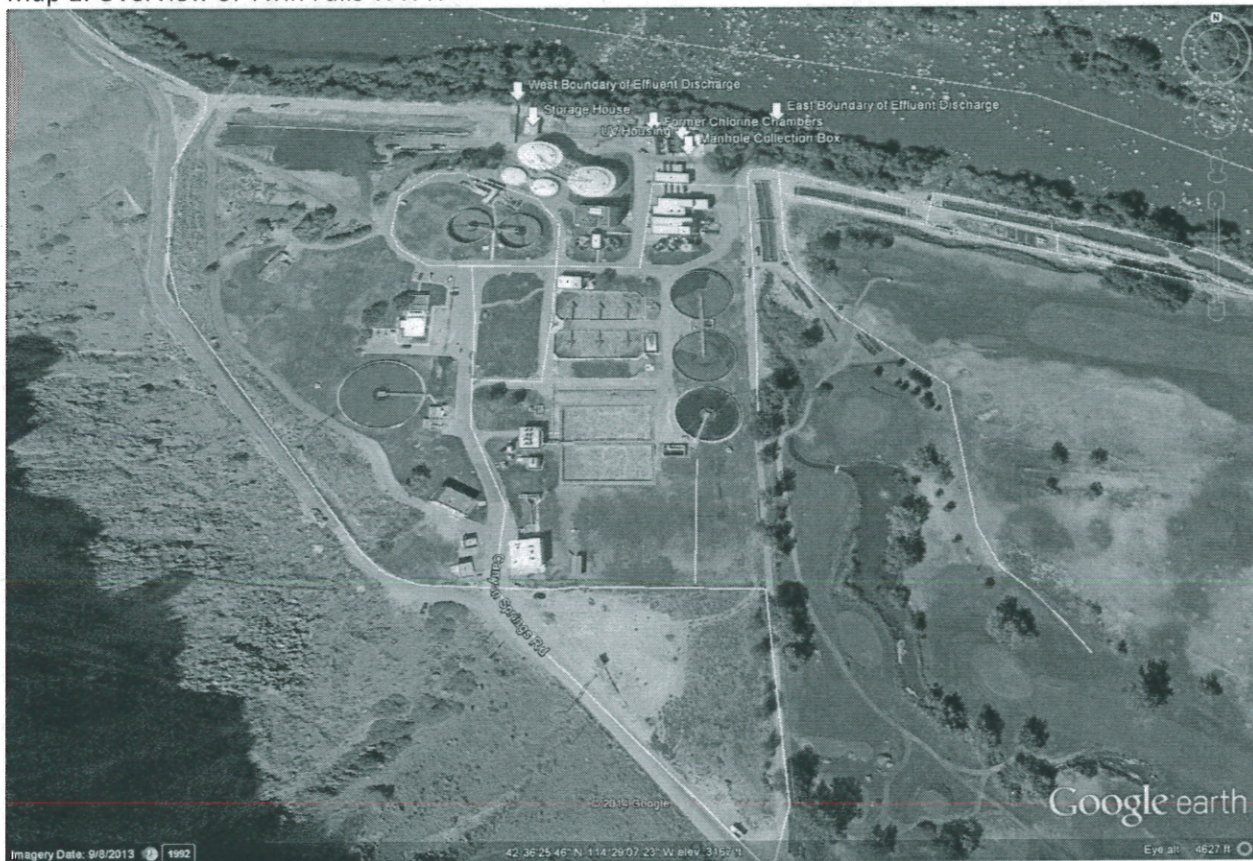
Two Google Earth maps of the facility location and the Manhole Collection Box are as follows:  
 Map 1. Overview of Twin Falls WWTP

The effluent discharge occurred on the northeast of the WWTP near the Snake River. The two solid red lines represent the estimate limits of effluent on the surface of the facility on the west and east side. The elevation change across the facility is as follows:

Within the range of the 2 solid red line =	3137' (average of 3 elevation locations)
Midway across the facility =	3163' (average of 3 elevation locations)
Across the south end of the facility =	3183' (average of 3 elevation locations)

There is approximately a 46' drop across the facility (from south to north), the lowest point being near the Manhole Collection Box.

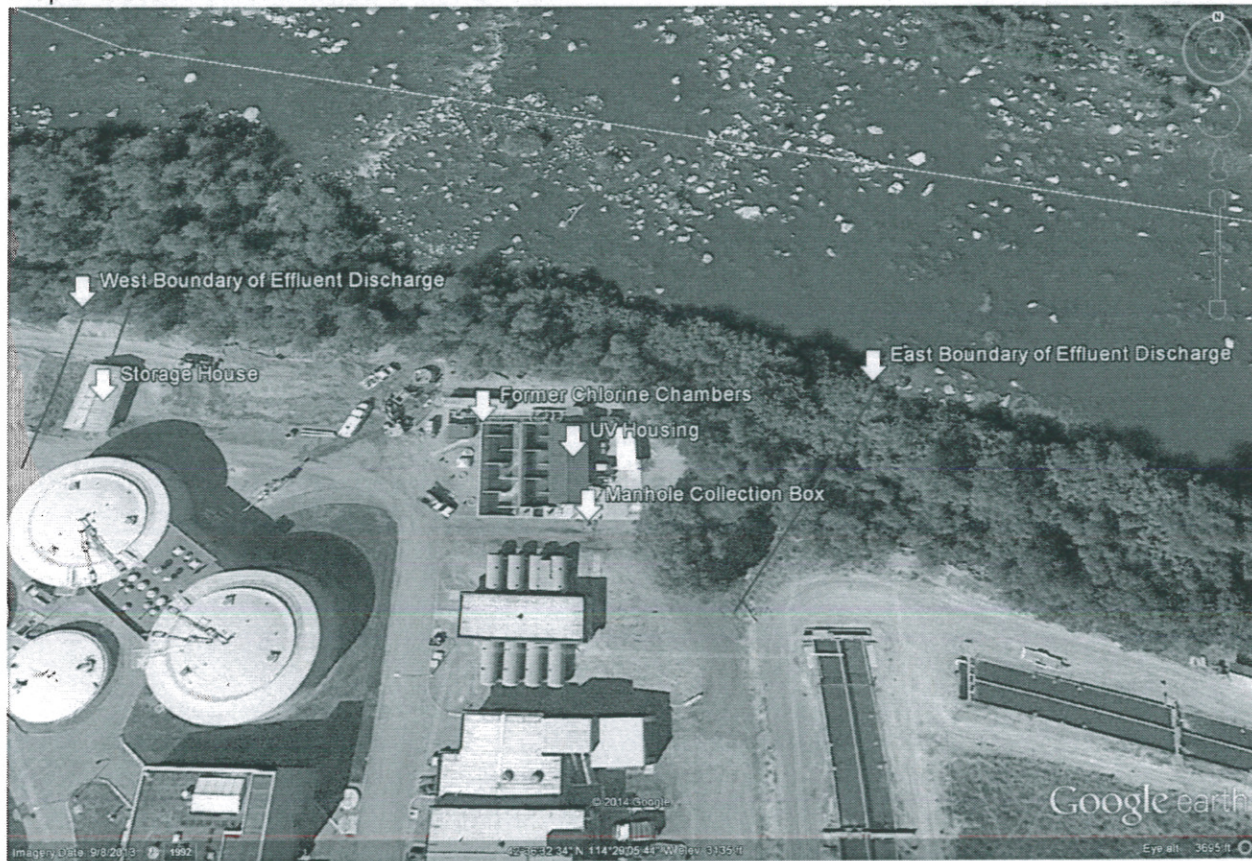
Map 2. Closer View of Manhole Collection Box

The 2 solid red lines (on the west end and on the east end) represent the east-west boundaries of the approximate location of effluent exposure on the surface of the facility. The 3<sup>rd</sup> red solid, on the west side, coming out of the Storage House, is a pipeline that runs direct to the facility. A concern for the facility will be to cap the discharge pipe so that no future discharges that end up here, end up being discharged in the Snake River. It is uncertain, at this time, exactly how much effluent wastewater was discharged into the Snake River.
